# BUILDING A WORLD OF DIFFERENCE

## W.229 ST. AND CLIFFORD DR. PROJECT W.227 ST PROJECT

FAIRVIEW PARK, OH

8 February, 2016

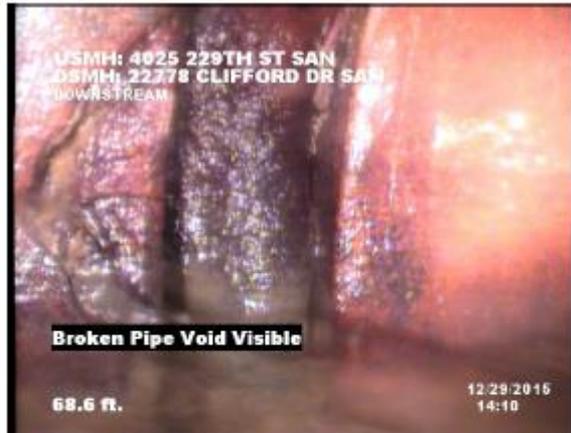
Distance: 68.6 ft. Grade: 5  
Condition: Broken Pipe Void Visible  
Remarks: N/A

- Line full length of sewer from Lorain Rd. to Clifford
- Replace perforated manhole lids with manhole lids
- CCTV Storm Sewer to determine if any repairs are required
- Post flow monitoring
- Recalibrate Model
- If significant I/I is not removed pursue private property investigation

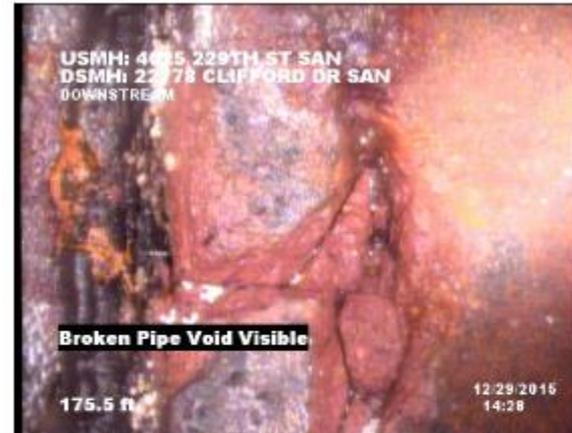
Distance: 175.5 ft. Grade: 5  
Condition: Broken Pipe Void Visible  
Remarks: N/A

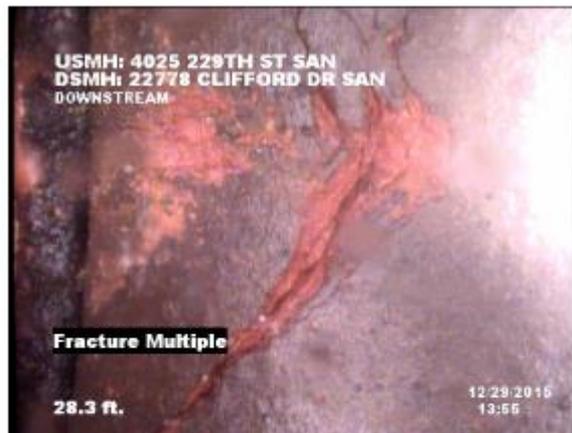
Distance: 28.3 ft. Grade: 4  
Condition: Fracture Multiple  
Remarks: N/A

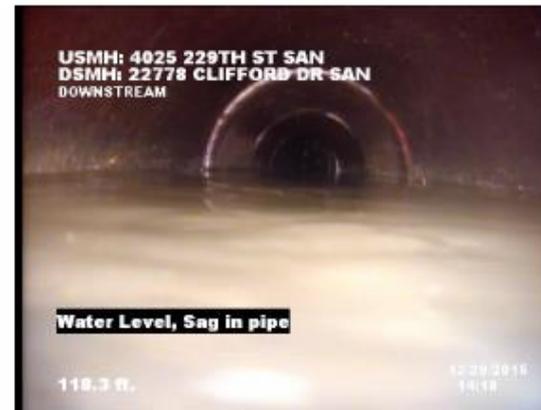
Distance: 118.3 ft. Grade: 3  
Condition: Water Level, Sag in pipe  
Remarks: N/A

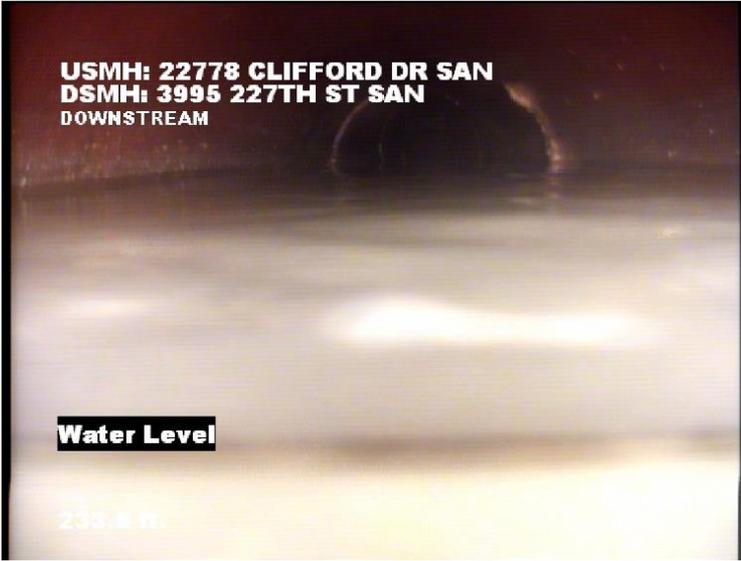
Distance:	233.8 ft.	Grade:	3
Condition:	Water Level		
Remarks:	N/A

Sagging Pipe

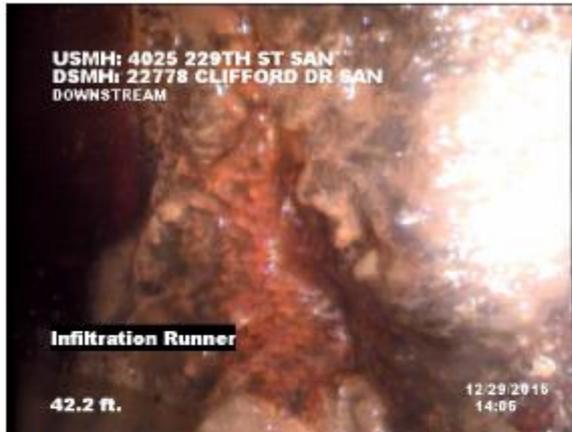
Distance: 42.2 ft. Grade: 4  
Condition: Infiltration Runner  
Remarks: N/A

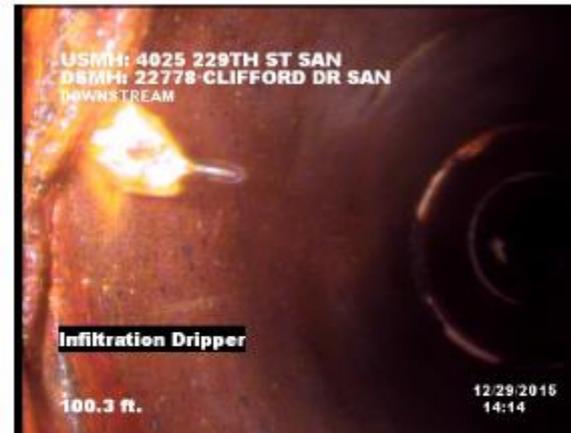
Distance: 100.3 ft. Grade: 3  
Condition: Infiltration Dripper  
Remarks: N/A

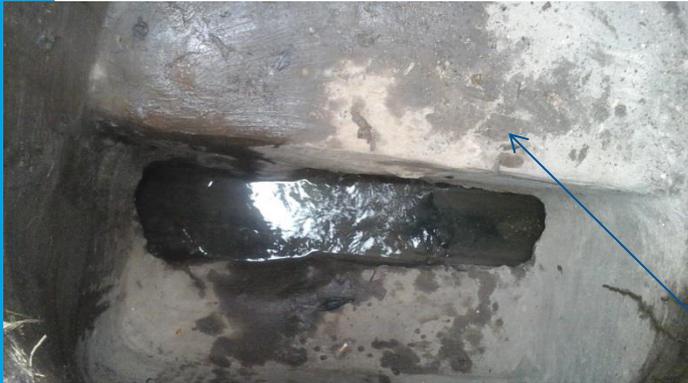
Lateral tap on the right side

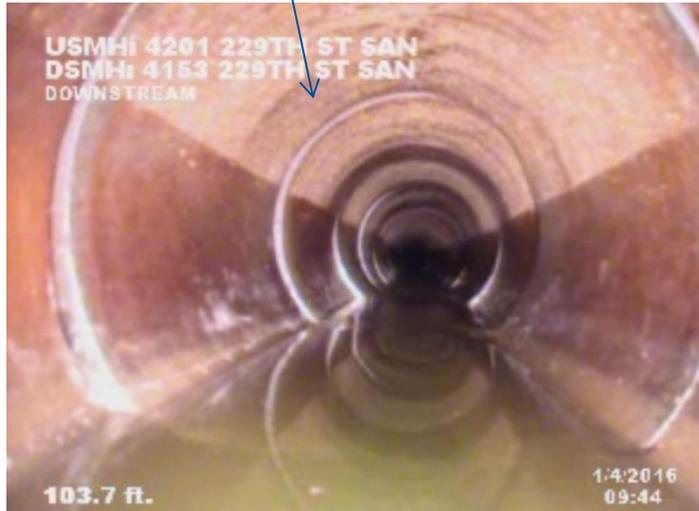
Lateral tap on the left side

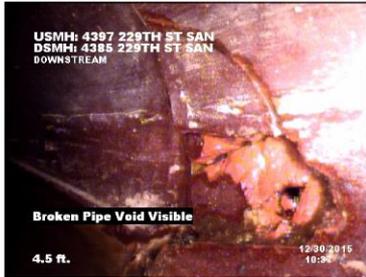
Distance: 4.5 ft. Grade: 5  
Condition: Broken Pipe Void Visible  
Remarks: N/A

**11 Broken Pipe Void Visible on Pipe 4397-4385 229<sup>th</sup> Street**

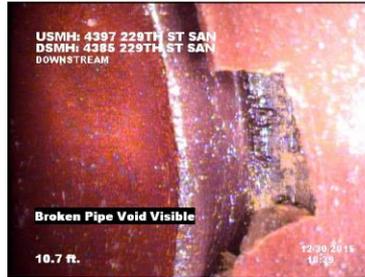
Distance: 10.7 ft. Grade: 5  
Condition: Broken Pipe Void Visible  
Remarks: N/A

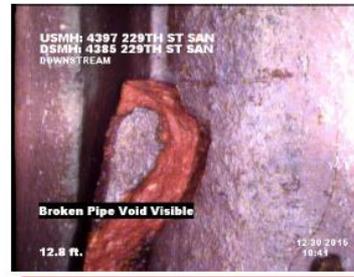
Distance: 12.8 ft. Grade: 5  
Condition: Broken Pipe Void Visible  
Remarks: N/A

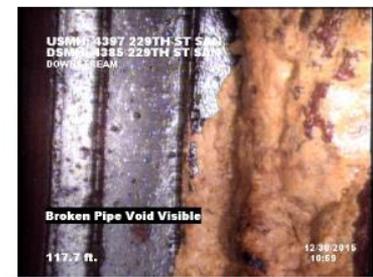
Distance: 117.7 ft. Grade: 5  
Condition: Broken Pipe Void Visible  
Remarks: N/A

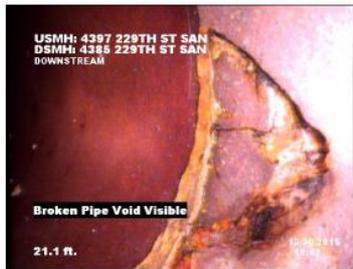
Distance: 21.1 ft. Grade: 5  
Condition: Broken Pipe Void Visible  
Remarks: N/A

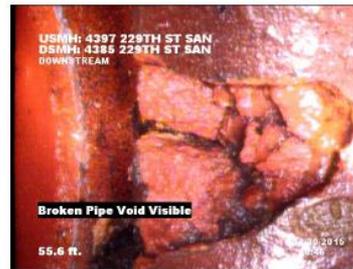
Distance: 55.6 ft. Grade: 5  
Condition: Broken Pipe Void Visible  
Remarks: N/A

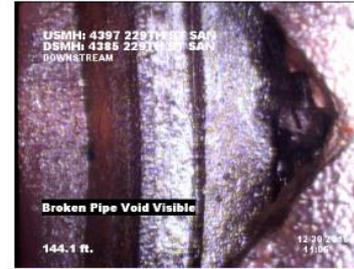
Distance: 144.1 ft. Grade: 5  
Condition: Broken Pipe Void Visible  
Remarks: N/A

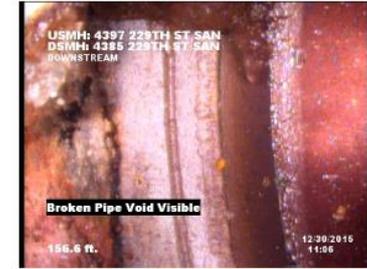
Distance: 156.6 ft. Grade: 5  
Condition: Broken Pipe Void Visible  
Remarks: N/A

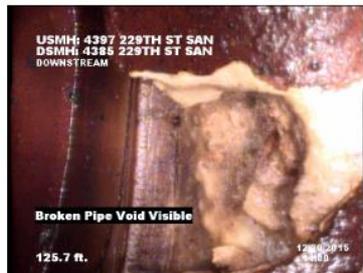
Distance: 125.7 ft. Grade: 5  
Condition: Broken Pipe Void Visible  
Remarks: N/A

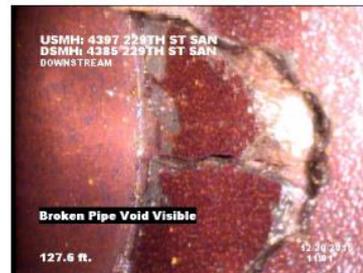
Distance: 127.6 ft. Grade: 5  
Condition: Broken Pipe Void Visible  
Remarks: N/A

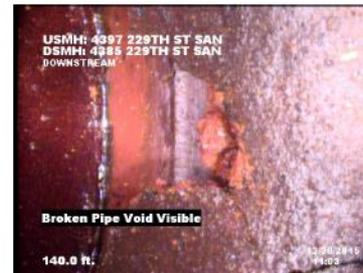
Distance: 140.0 ft. Grade: 5  
Condition: Broken Pipe Void Visible  
Remarks: N/A

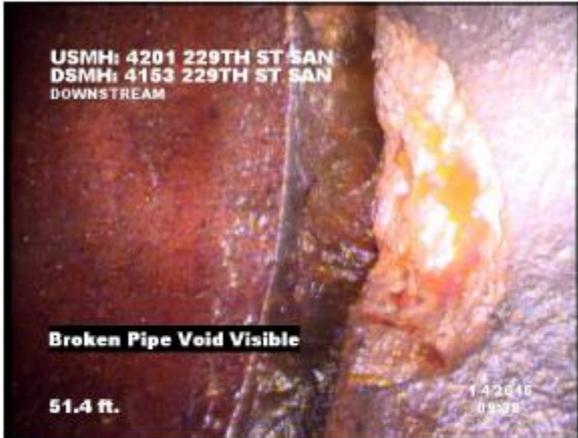
Distance: 51.4 ft.      Grade: 5  
Condition: Broken Pipe Void Visible  
Remarks: N/A

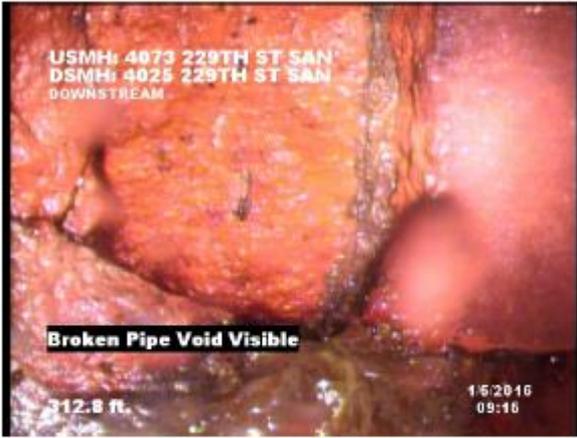
Distance: 312.8 ft.      Grade: 5  
Condition: Broken Pipe Void Visible  
Remarks: N/A

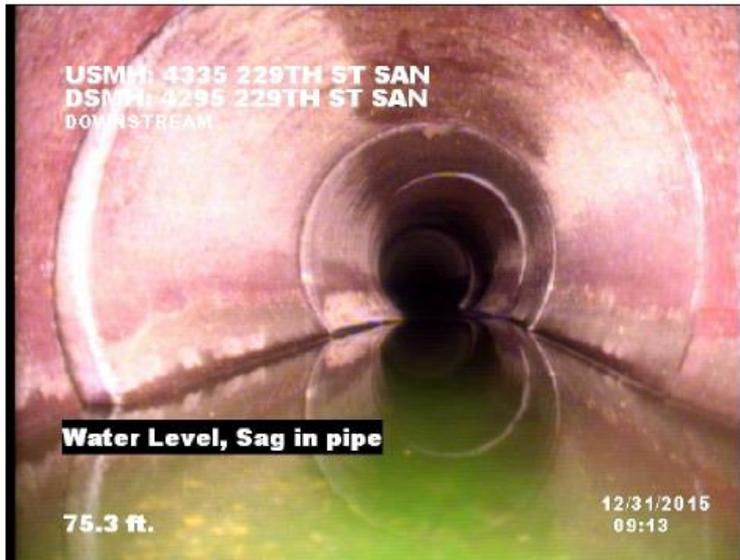
Distance: 75.3 ft. Grade: 2  
Condition: Water Level, Sag in pipe  
Remarks: N/A

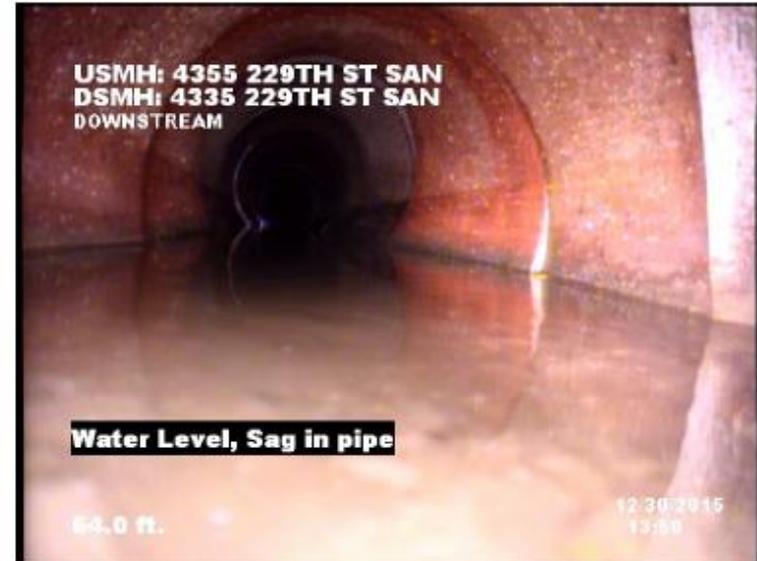
Distance: 64.0 ft. Grade: 2  
Condition: Water Level, Sag in pipe  
Remarks: N/A

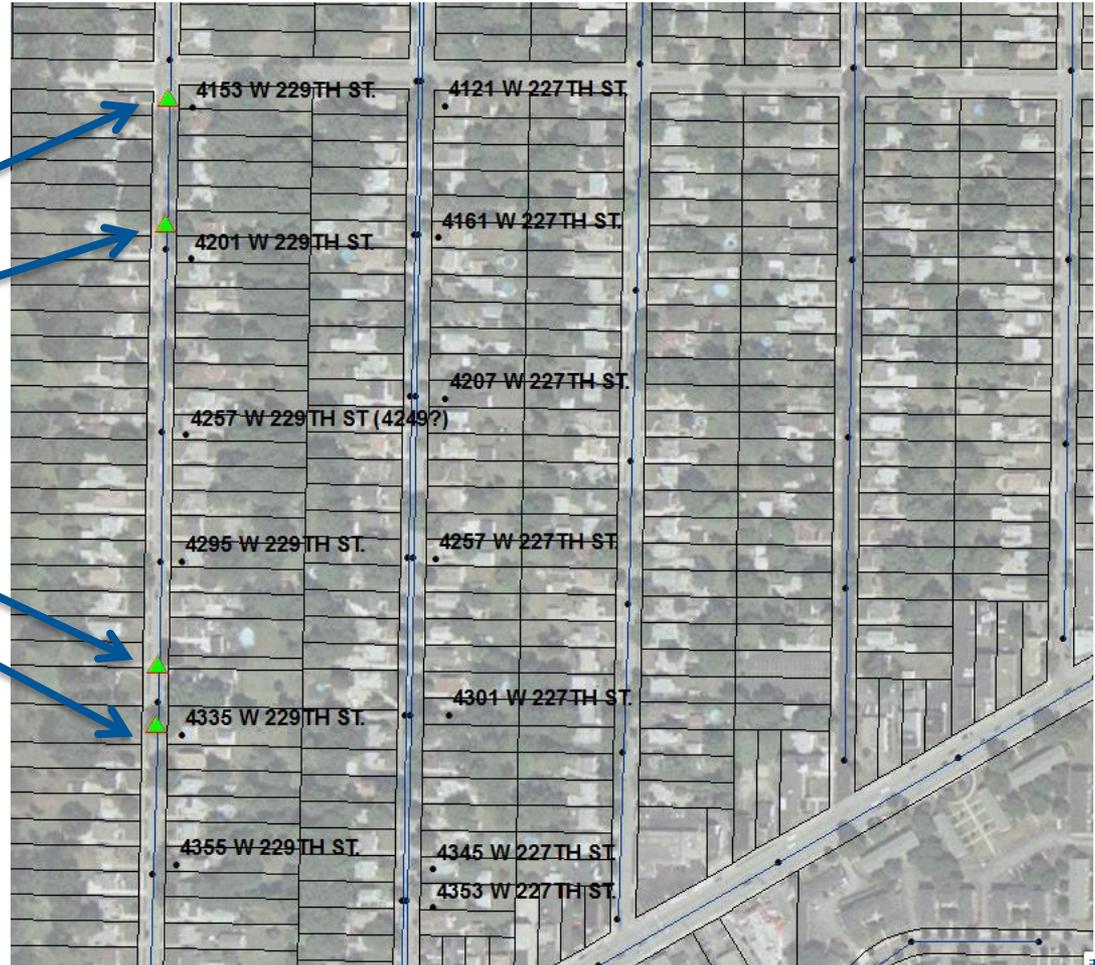
4 Positive Locations all found along 229<sup>th</sup> St

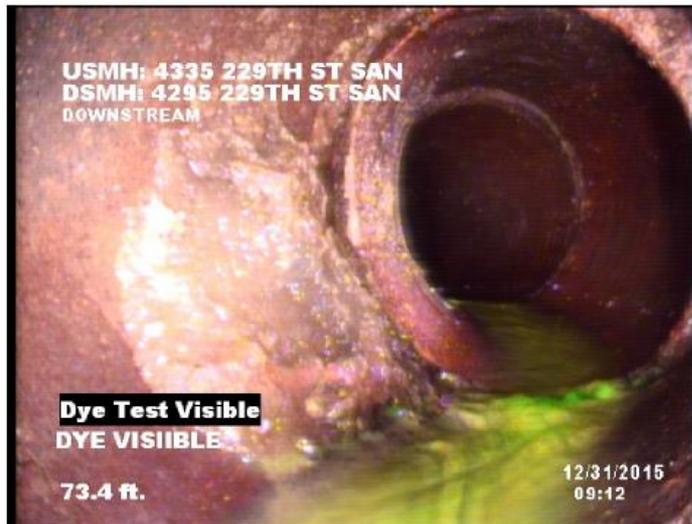
4335-4295 229<sup>th</sup> St

Distance: 73.4 ft.      Grade: 5  
Condition: Dye Test Visible  
Remarks: DYE VISIIBLE

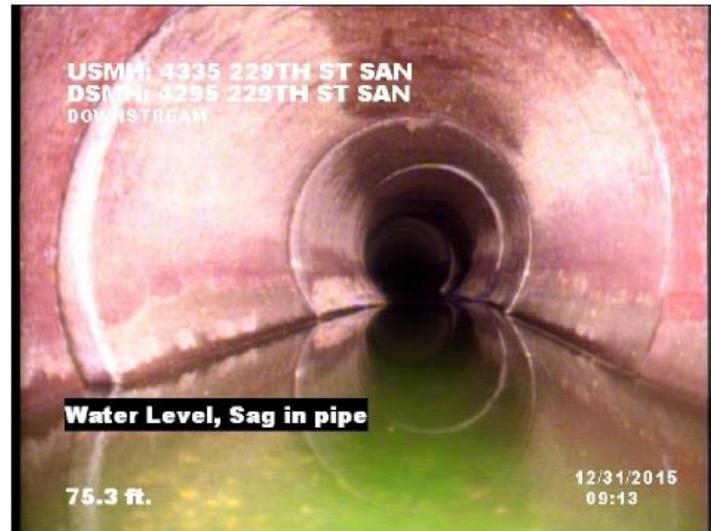
Distance: 75.3 ft.      Grade: 2  
Condition: Water Level, Sag in pipe  
Remarks: N/A

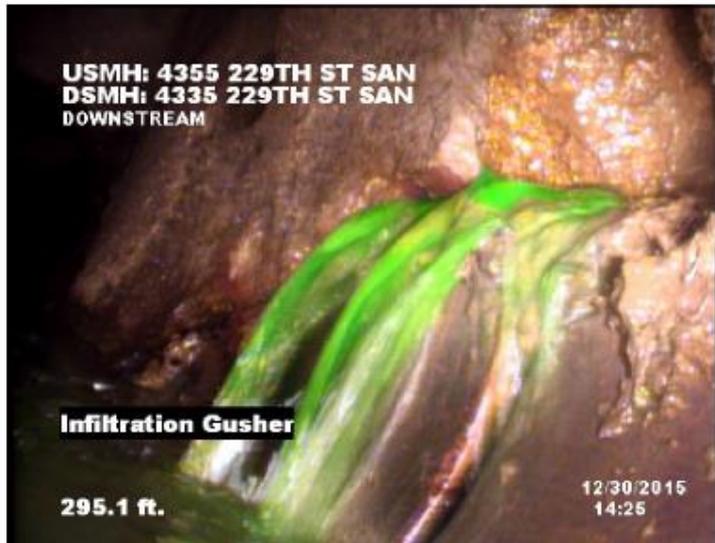
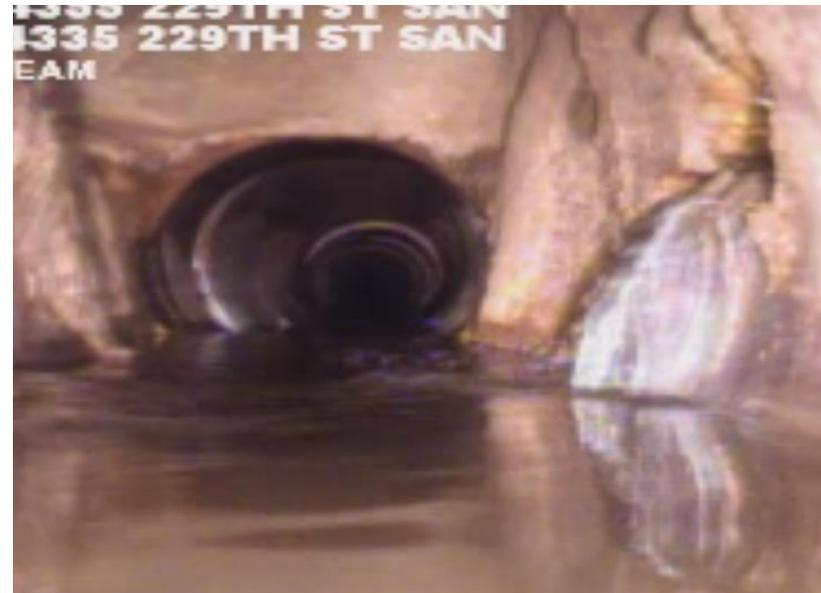
4355-4335 229<sup>th</sup> St

Under the Manhole

Distance: 295.1 ft.      Grade: 5  
Condition: Infiltration Gusher  
Remarks: N/A

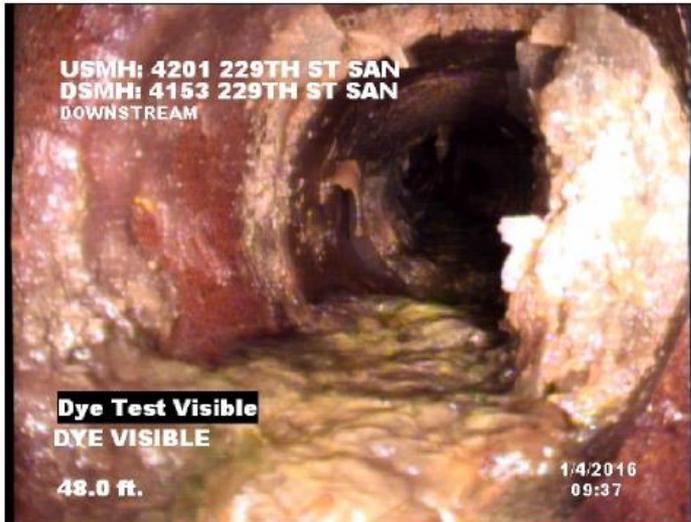
4201-4153 229<sup>th</sup> St

Distance: 48.0 ft. Grade: 5  
Condition: Dye Test Visible  
Remarks: DYE VISIBLE

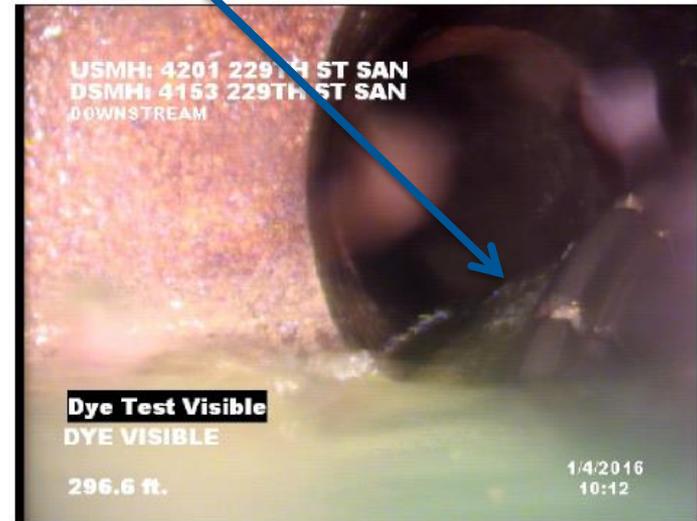
Distance: 296.6 ft. Grade: 5  
Condition: Dye Test Visible  
Remarks: DYE VISIBLE

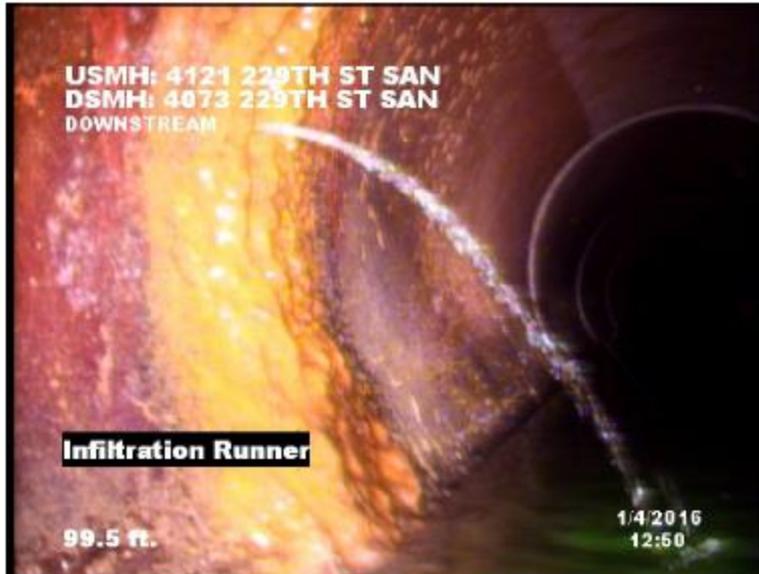
Distance: 99.5 ft. Grade: 4  
Condition: Infiltration Runner  
Remarks: N/A

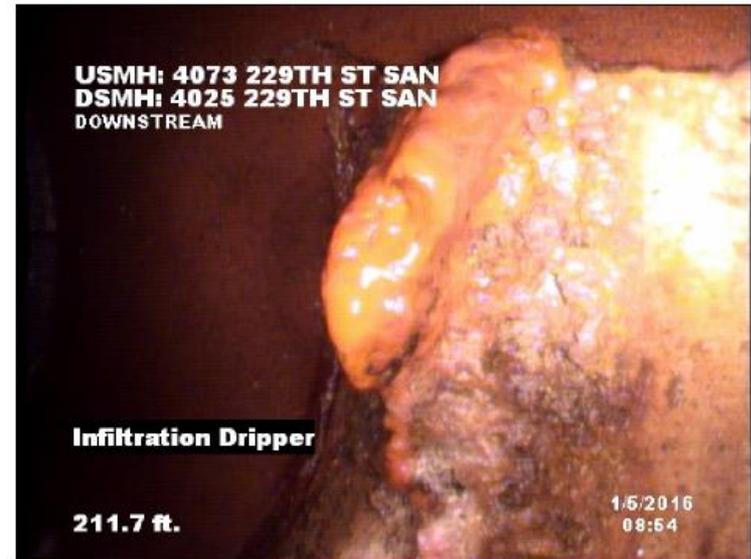
Distance: 211.7 ft. Grade: 3  
Condition: Infiltration Dripper  
Remarks: N/A

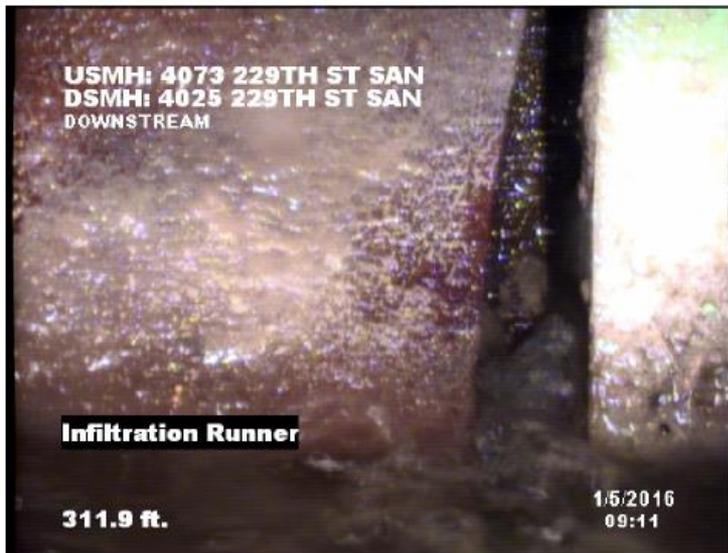
Distance: 311.9 ft. Grade: 4  
Condition: Infiltration Runner  
Remarks: N/A

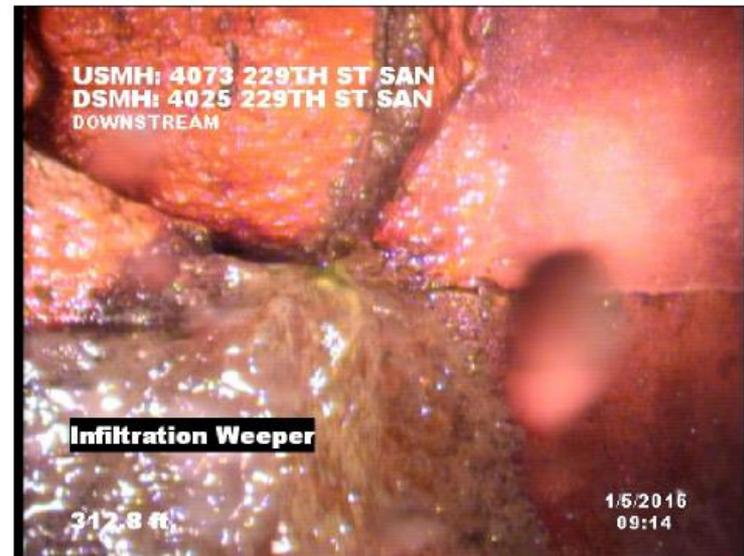
Distance: 312.8 ft. Grade: 2  
Condition: Infiltration Weeper  
Remarks: N/A

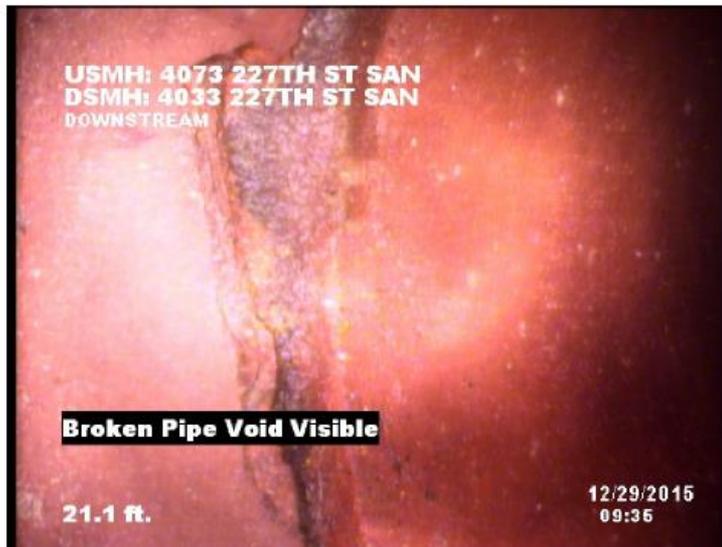
Distance: 21.1 ft. Grade: 5  
Condition: Broken Pipe Void Visible  
Remarks: N/A

- Meet with Residents to Discuss Flooding Concerns
- Perform Private Property Investigation
- CCTV Storm Sewer
- Recalibrate Model
- Determine Next Steps

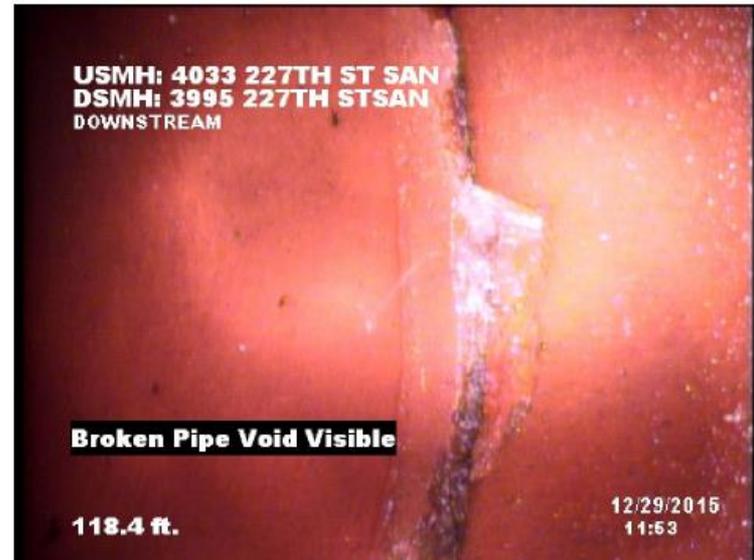
Distance: 118.4 ft. Grade: 5  
Condition: Broken Pipe Void Visible  
Remarks: N/A

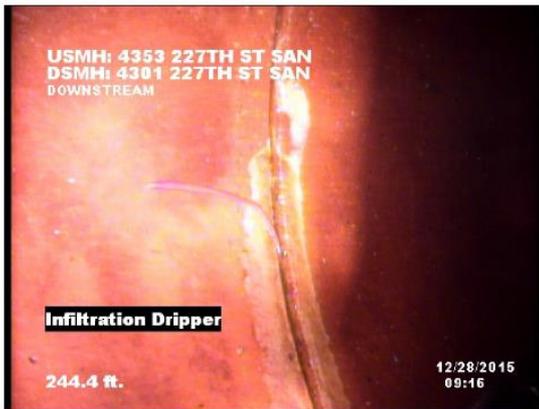
Distance: 244.4 ft. Grade: 3  
Condition: Infiltration Dripper  
Remarks: N/A

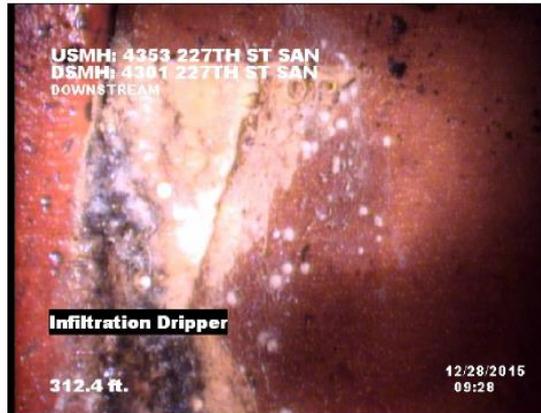
Distance: 312.4 ft. Grade: 3  
Condition: Infiltration Dripper  
Remarks: N/A

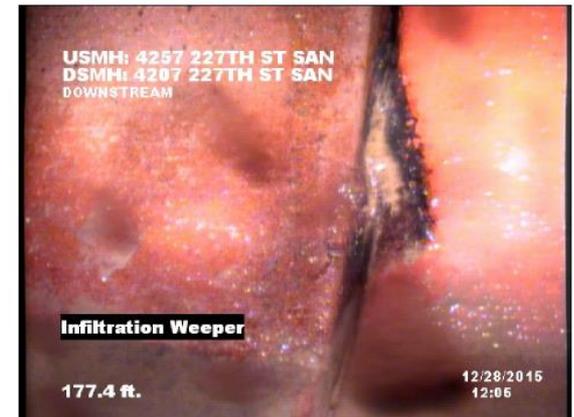
Distance: 177.4 ft. Grade: 2  
Condition: Infiltration Weeper  
Remarks: N/A
