# **FAIRVIEW PARK CITY COUNCIL MEETING NOTICE**

# CITY OF FAIRVIEW PARK CITY COUNCIL MEETING AGENDA

## SPECIAL COUNCIL MEETING MONDAY, JULY 25, 2016

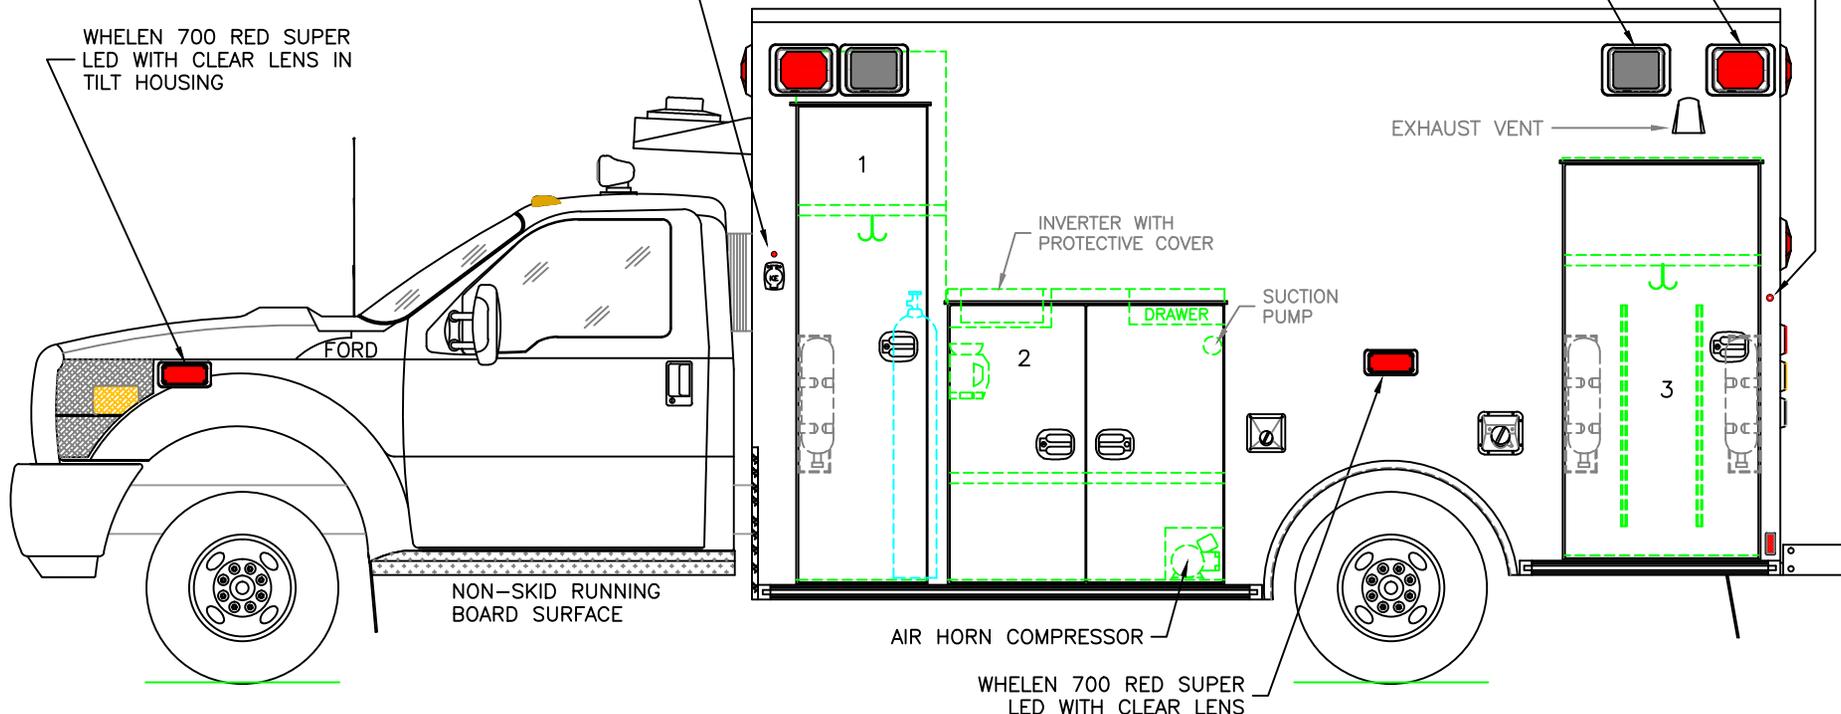
COMPARTMENT  
 O.S.S #1

CLEAR OPENING: 77.00h x 18.25w  
 INSIDE DIM'S.: 86.75h x 24.50w x 20.75d  
 "M" OXYGEN TANK STORAGE  
 ANGLED SCBA BRACKET IN FORWARD CORNER  
 (1) ADJ. SHELF ABOVE THE OXYGEN  
 (2) COAT HOOKS MOUNTED TO SHELF

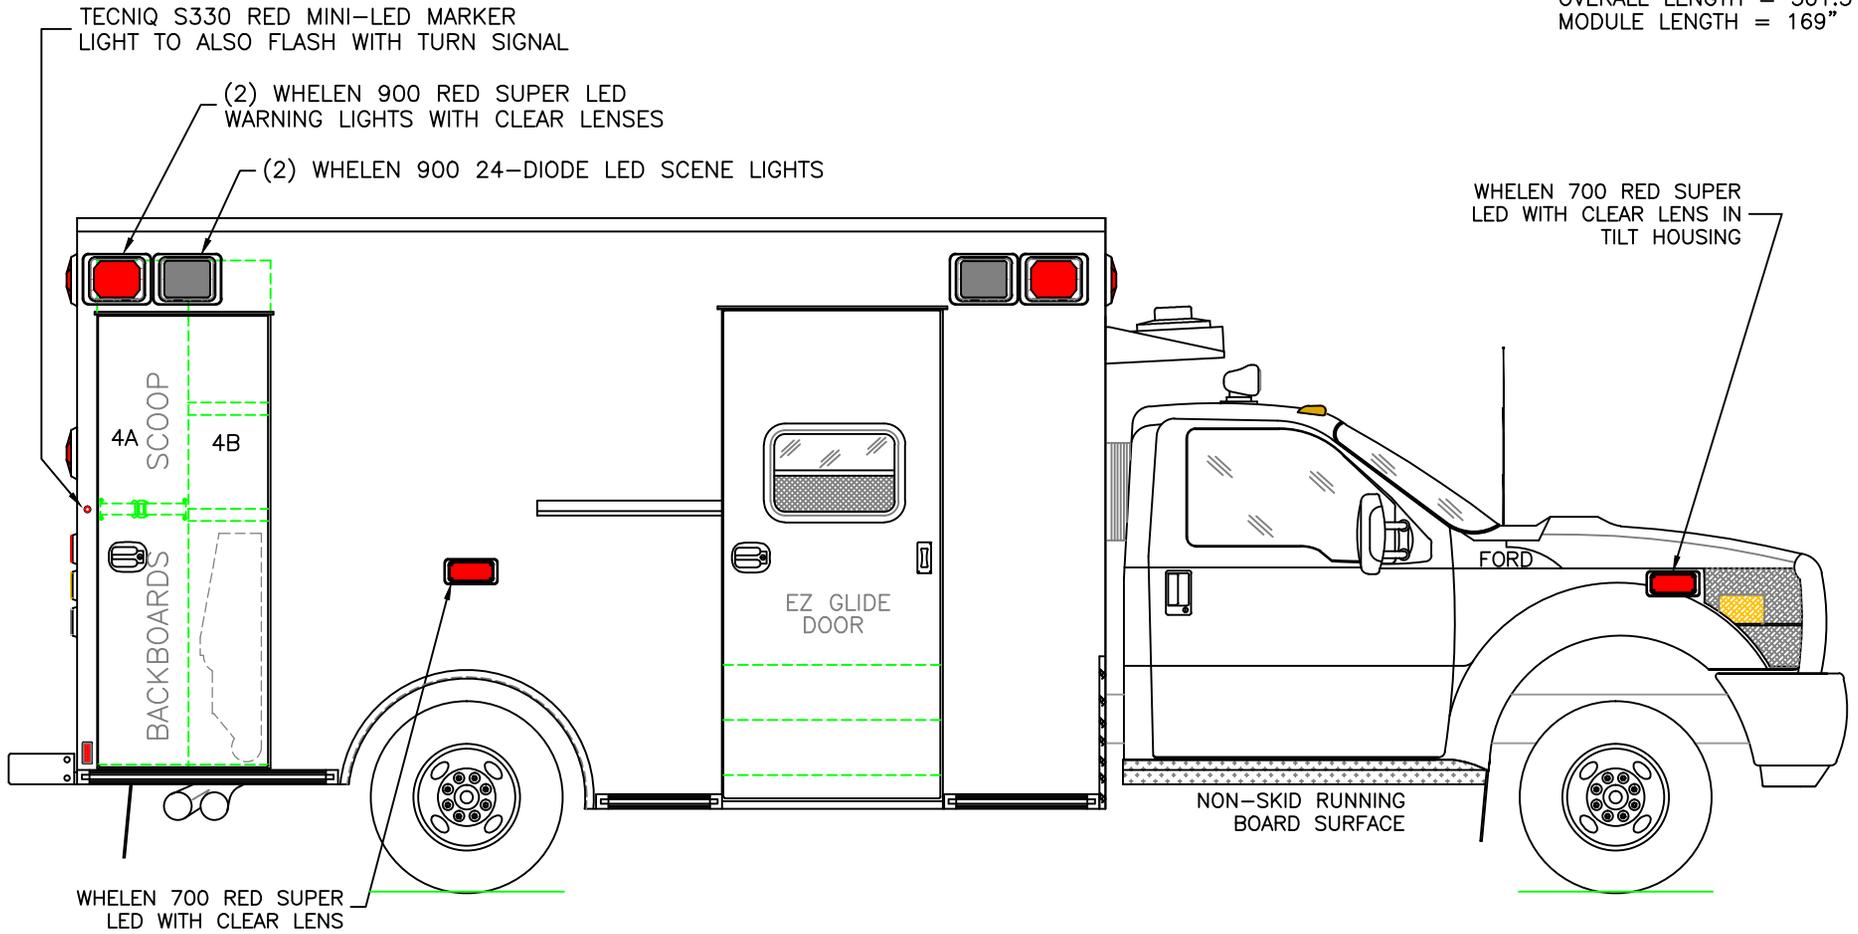
2016 CURBSIDE EXTERIOR VIEW CHIEF XL-1/FORD F-550 CHASSIS	DATE: 4-8-16 DWG. AAB REV. A	DRAWING NO. FPFD-4
----------------------------------	---	--	---------------------------------------	-----------------------

COMPARTMENT  
 O.S.S #4  
 CLEAR OPENING: 73.00h x 24.75w  
 INSIDE DIM'S. 4A: 82.75h x 15.00w x 20.75d  
 BACKBOARD/SCOOP STORAGE WITH STRAP  
 INSIDE DIM'S. 4B: 82.75h x 13.50w x 20.75d  
 (2) ADJUSTABLE SHELVES WITH I/O ACCESS  
 STAIR CHAIR STORAGE BELOW SHELVES

-COMPARTMENTS TO HAVE 2" LED LIGHTING

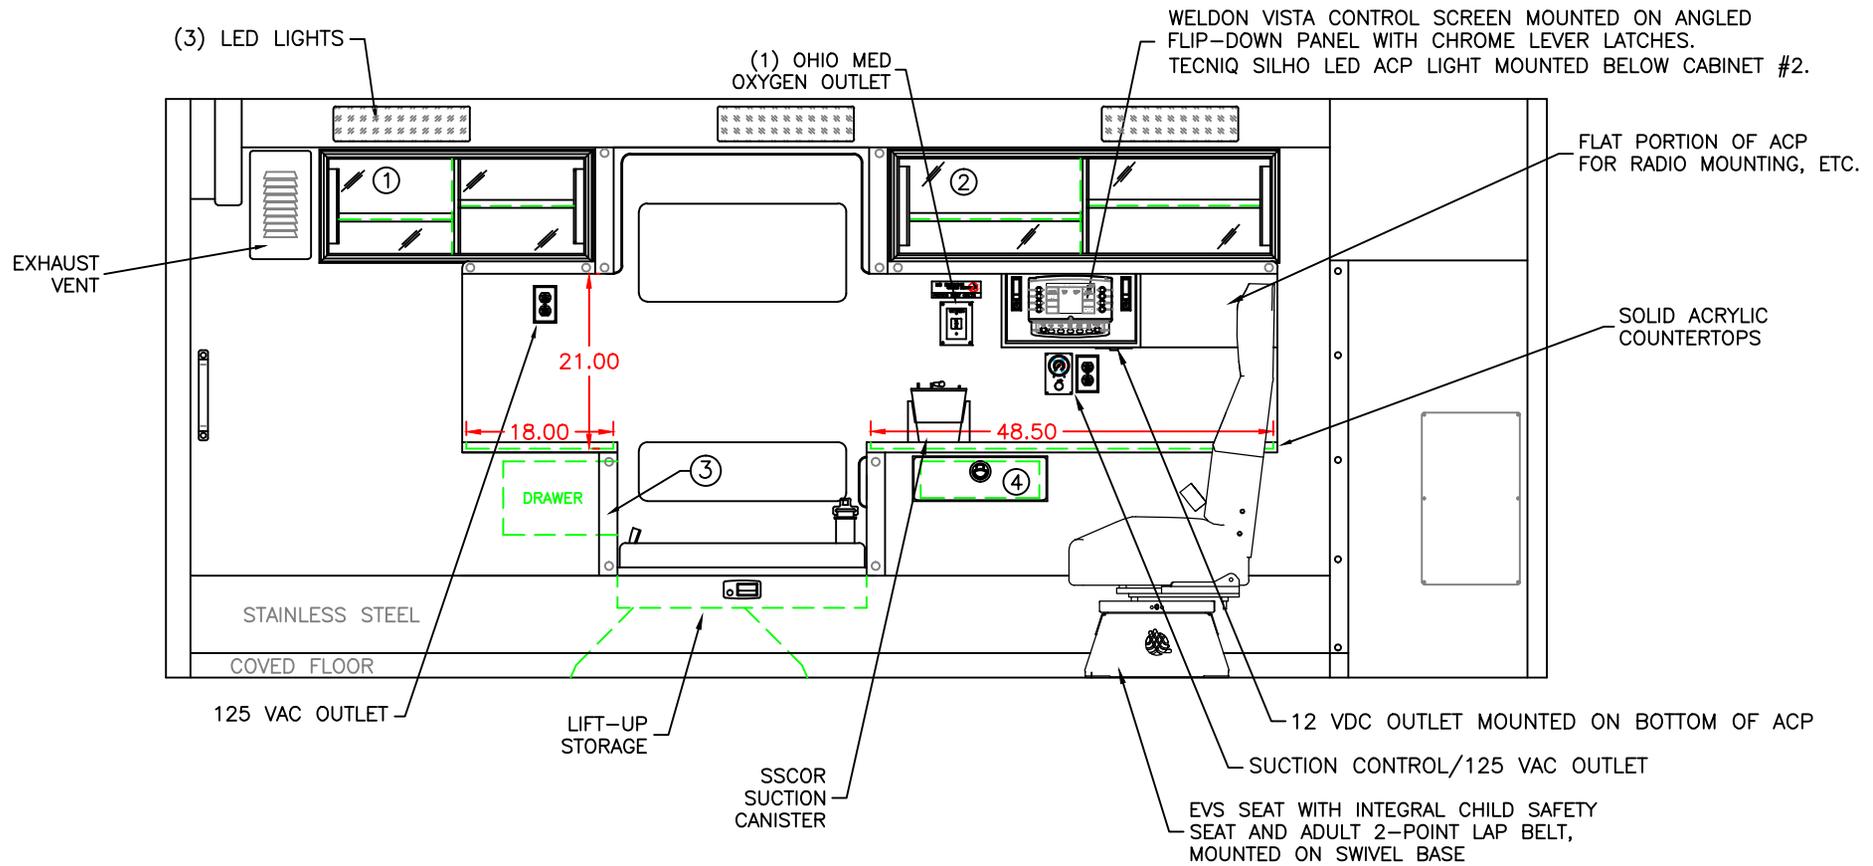
DRAWING NO.	FPFD-5
-------------	--------

COMPARTMENT

#1 DOOR OPENING: 11.50h x 31.25w  
 INSIDE DIMS: 13.25h x 33.00w x 17.25d  
 (1) ADJ SHELF EACH SIDE OF CENTER DIVIDER  
 SLIDING ACRYLIC CABINET DOORS

#3 = DRAWER THAT PULLS-OUT TOWARD CPR SEAT  
 INSIDE DIMS: 9.00h x 9.00w x 12.00d  
 LOCKING STAINLESS STEEL FLUSH PULL LATCHES

#4 PULL-OUT DRAWER WITH HINGED ACRYLIC WRITING SURFACE  
 INSIDE DIMS: 4.50h x 14.50w x 13.25d  
 LOCKING STAINLESS STEEL FLUSH PULL LATCH

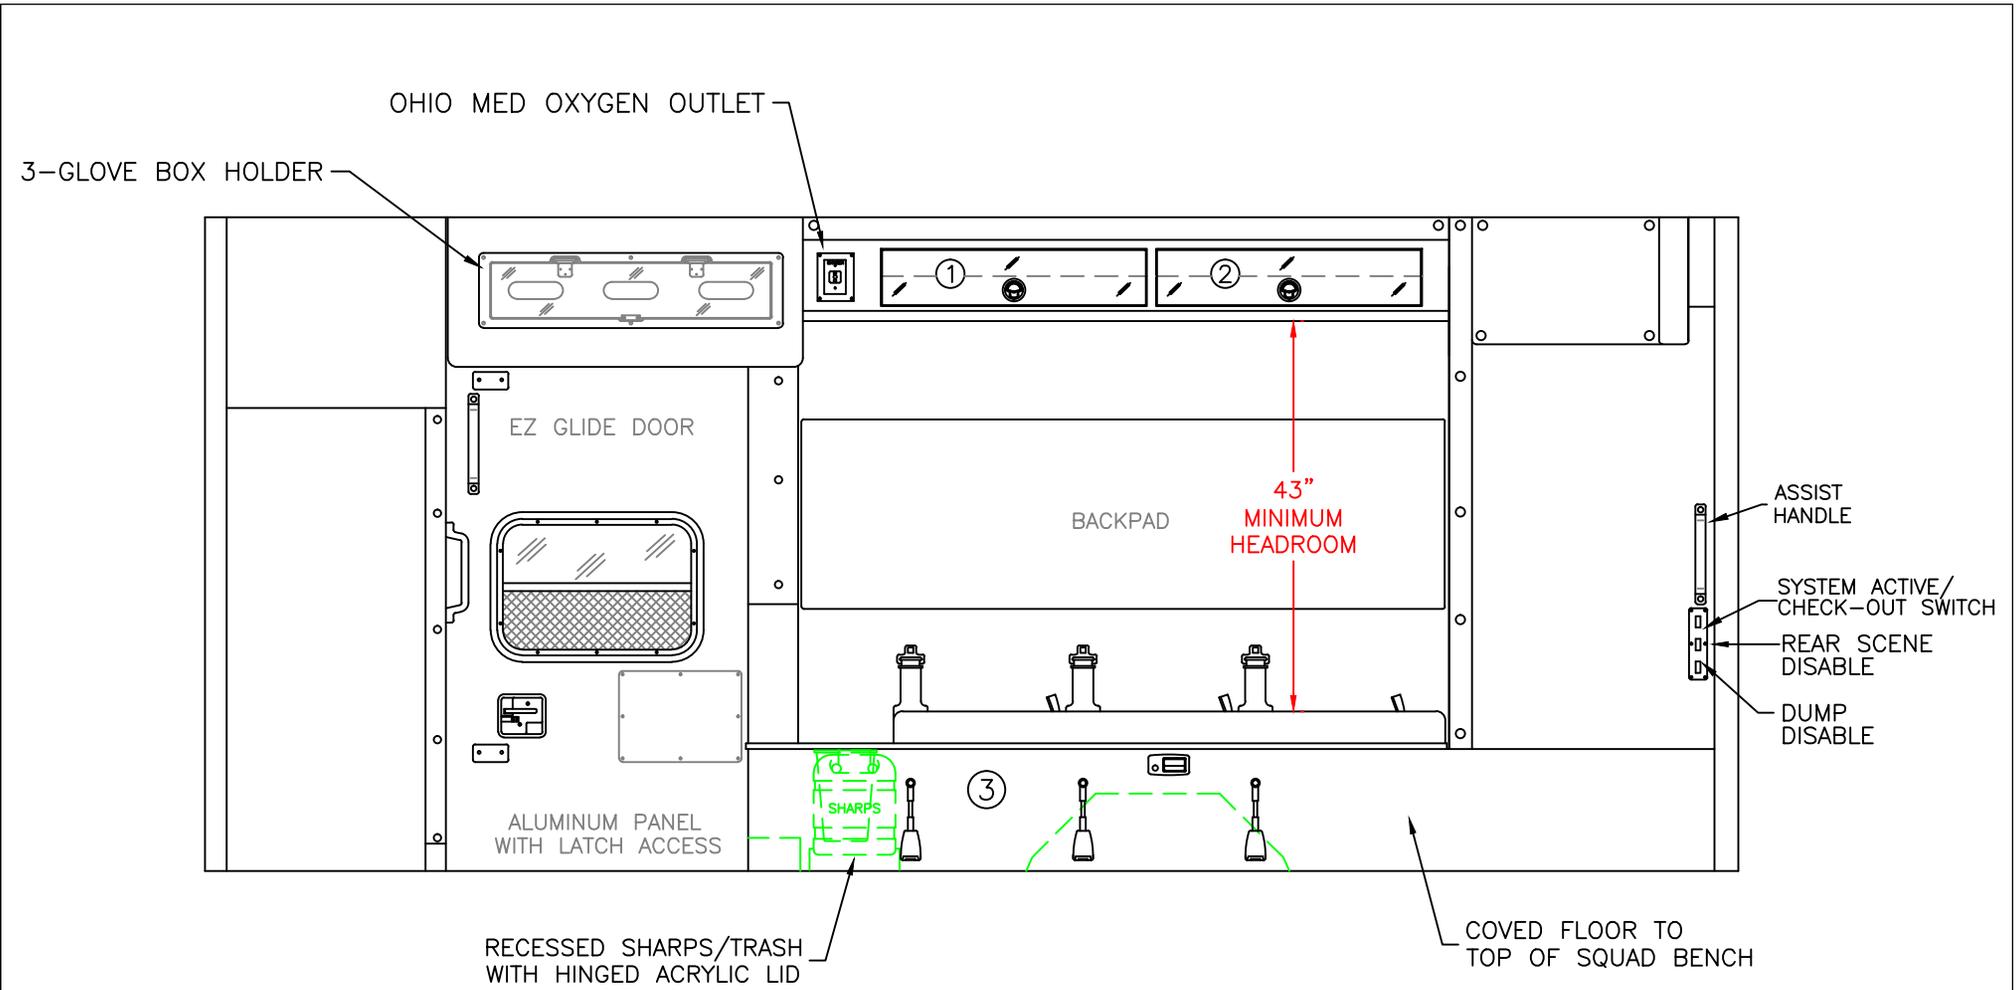
COMPARTMENT  
 #1/#2 DOOR OPENING: 6.25h x 29.25w  
 INSIDE DIMS: 6.25h x 29.25w x 10.25d  
 TOP HINGED ACRYLIC CABINET DOORS  
 LOCKING STAINLESS STEEL FLUSH PULL LATCHES

#3 INSIDE DIM'S: 14.25h x 77.00w x 21.00d

CABINETS TO BE ALUMINUM

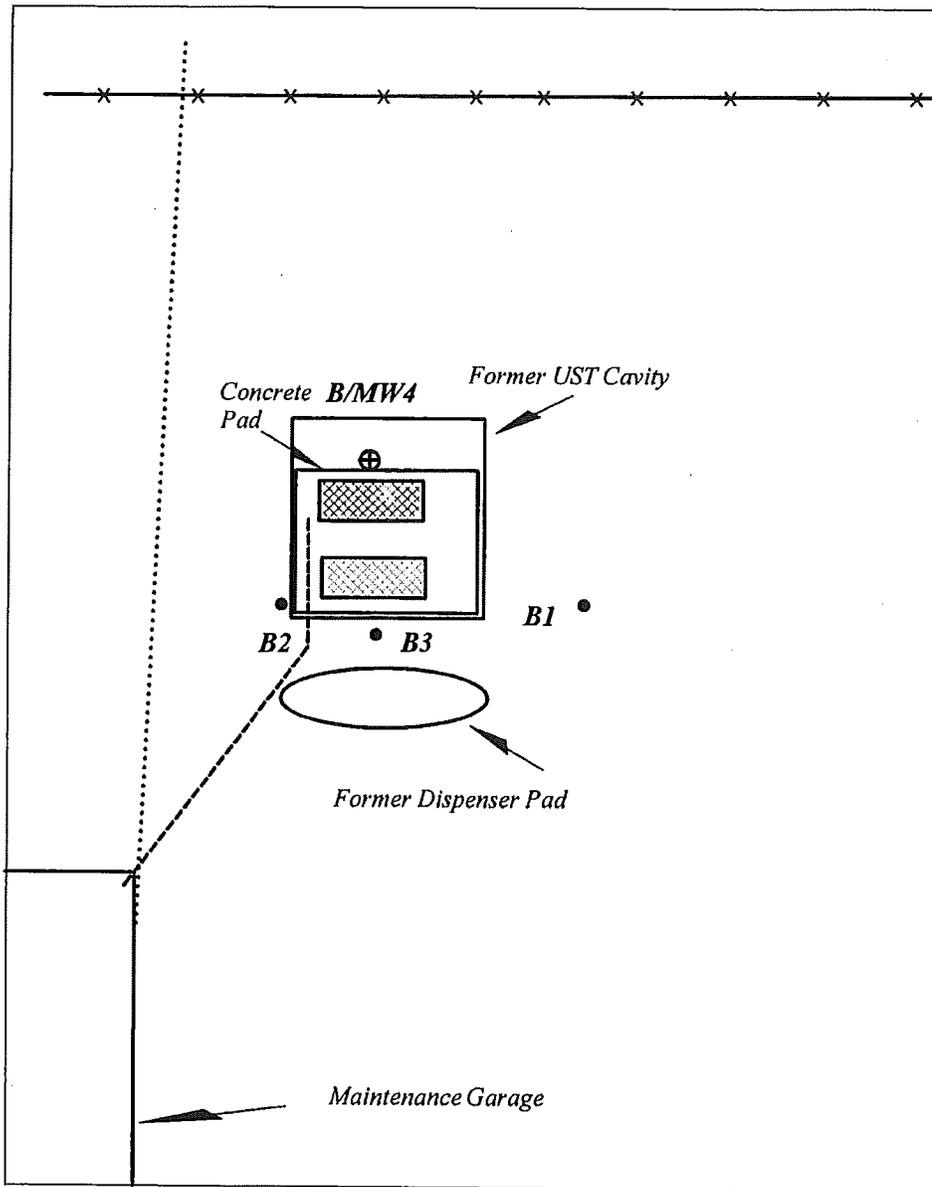
Figure 2:	Site Map
Project Name:	Tier 1 Source Investigation
Location:	20777 Lorain Road
	Fairview Park, Cuyahoga County, Ohio
EEl Project #:	16-3731
Prepared By:	WM/April 2016

- Gasoline and Diesel ASTs
- B/MW5** Monitoring Well
- B8** Boring
- Overhead power line
- Fence Line
- Underground power line

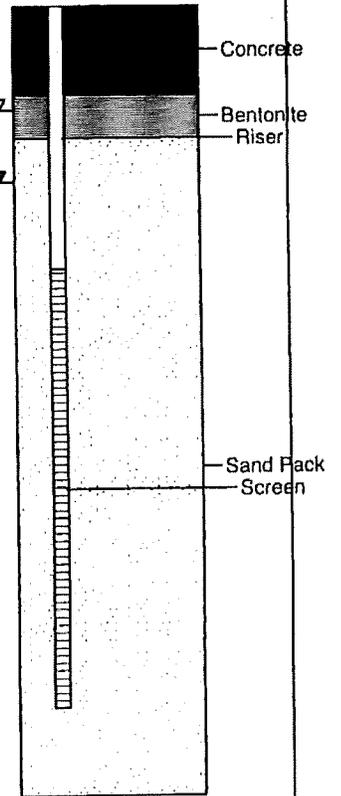
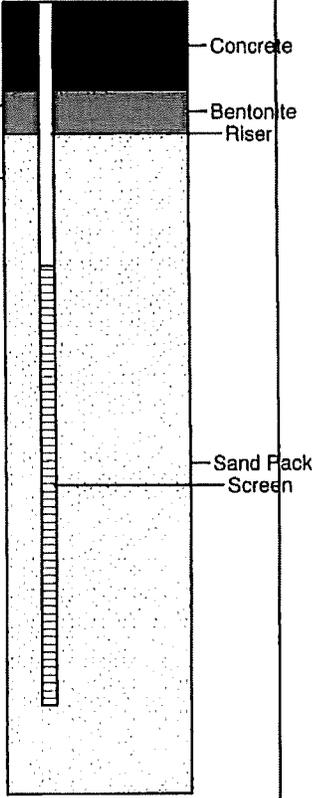
ML		Moist, brown, silty SAND, trace gravel [Fill]					
		CL		Moist, brown with gray mottling, lean CLAY (CL), trace sand, trace gravel [Fill]	1	YES	25.1	1.5	
2				Wet, GRAVEL (GM), trace sand, trace silt (pea gravel backfill)	2	NO	51.8	50	
4					3	NO	190	50	
6		GM			4	NO	15.0	50	
8					5	NO	27.8	50	
10					6	NO	142	66

12		CL		Moist, brown, lean (CLAY (CL), trace sand, trace gravel					
14				Refusal @ 12' HSA used to install monitoring well after geoprobe sampling was completed.

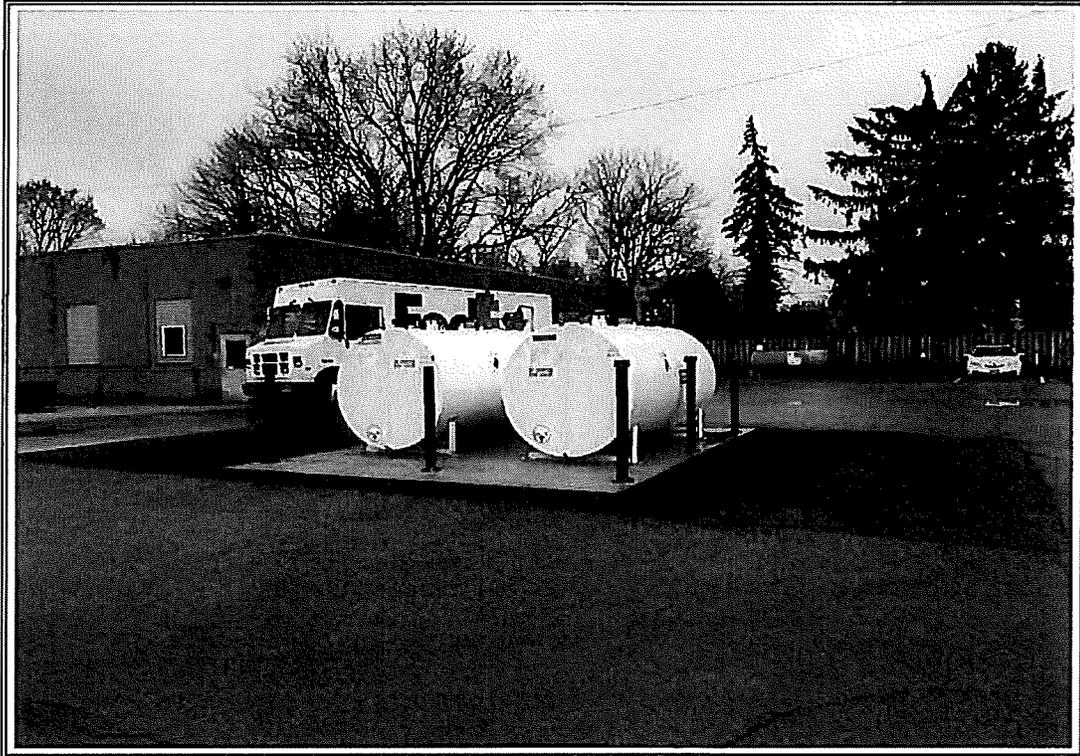
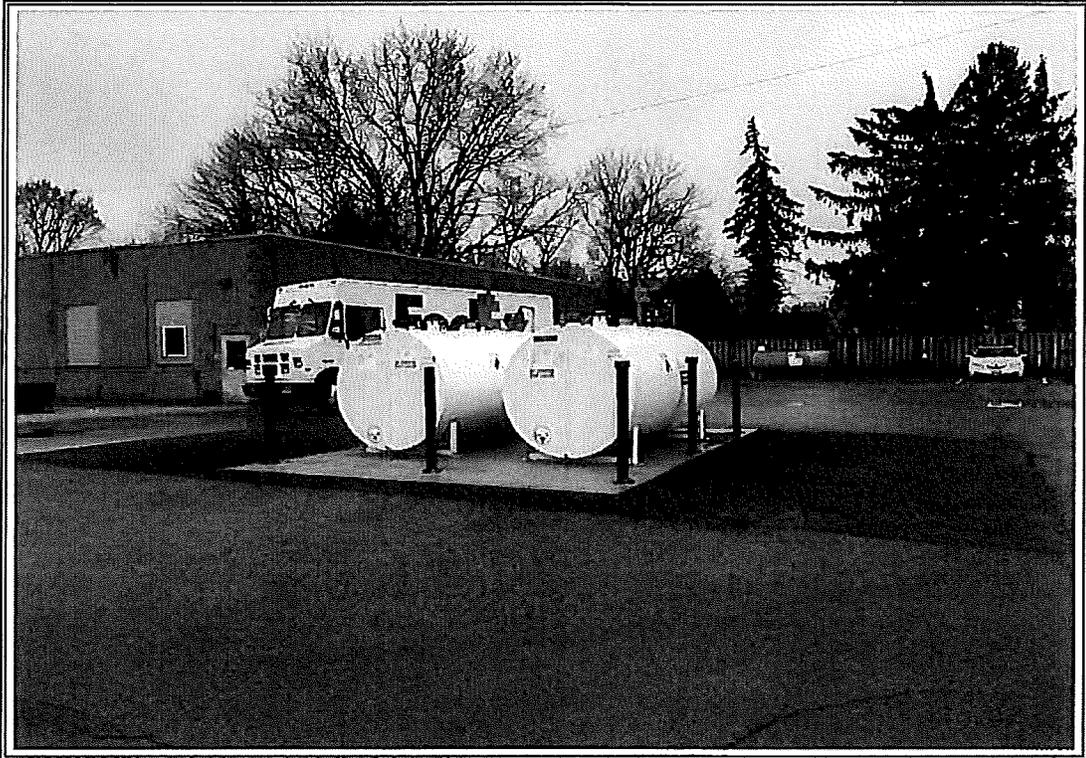
**Photograph No. 1**

View of the former UST area looking southwest.

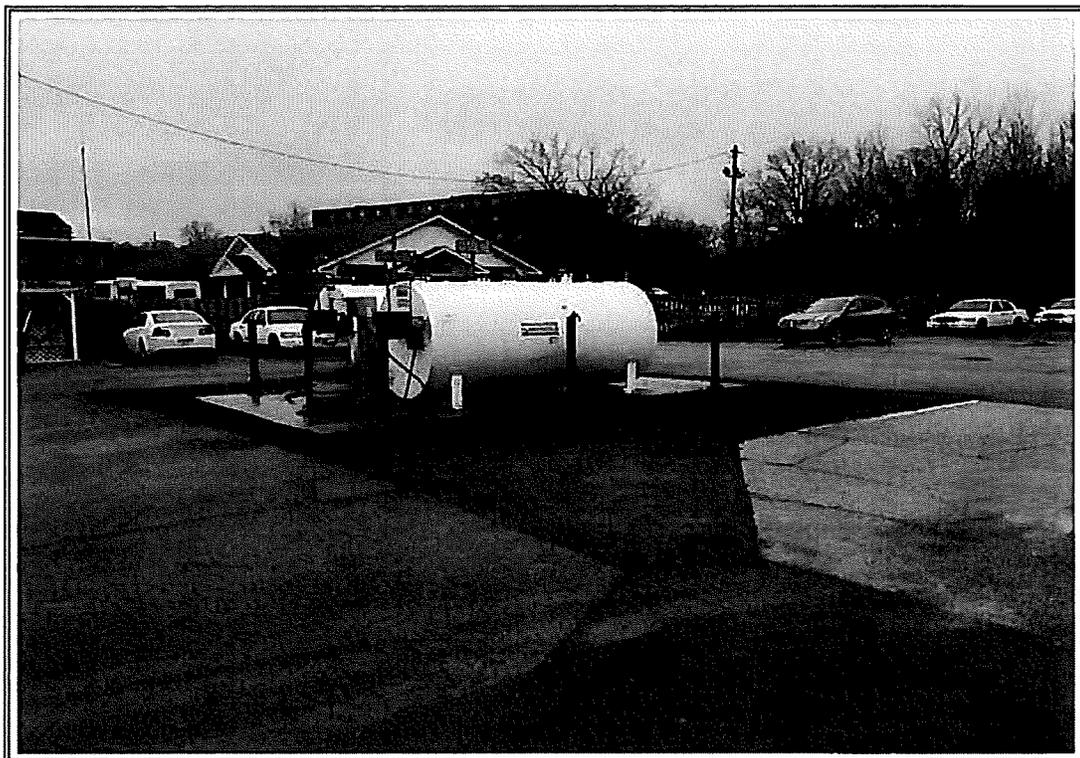
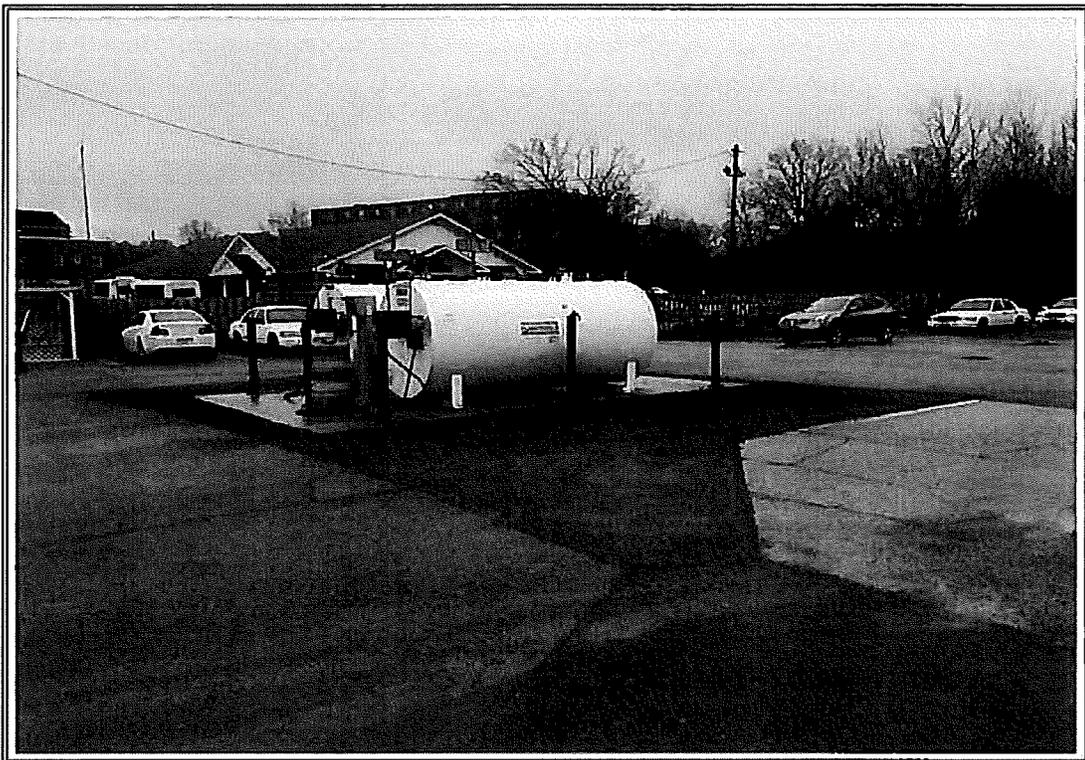
**Photograph No. 2**

View of the former UST location looking northeast.
